## CCTV DRAIN SURVEY

Date of Survey -  
4<sup>th</sup> June 2019

Site Address –  
Needspace, Shepherds Bush Road, W6 7AS

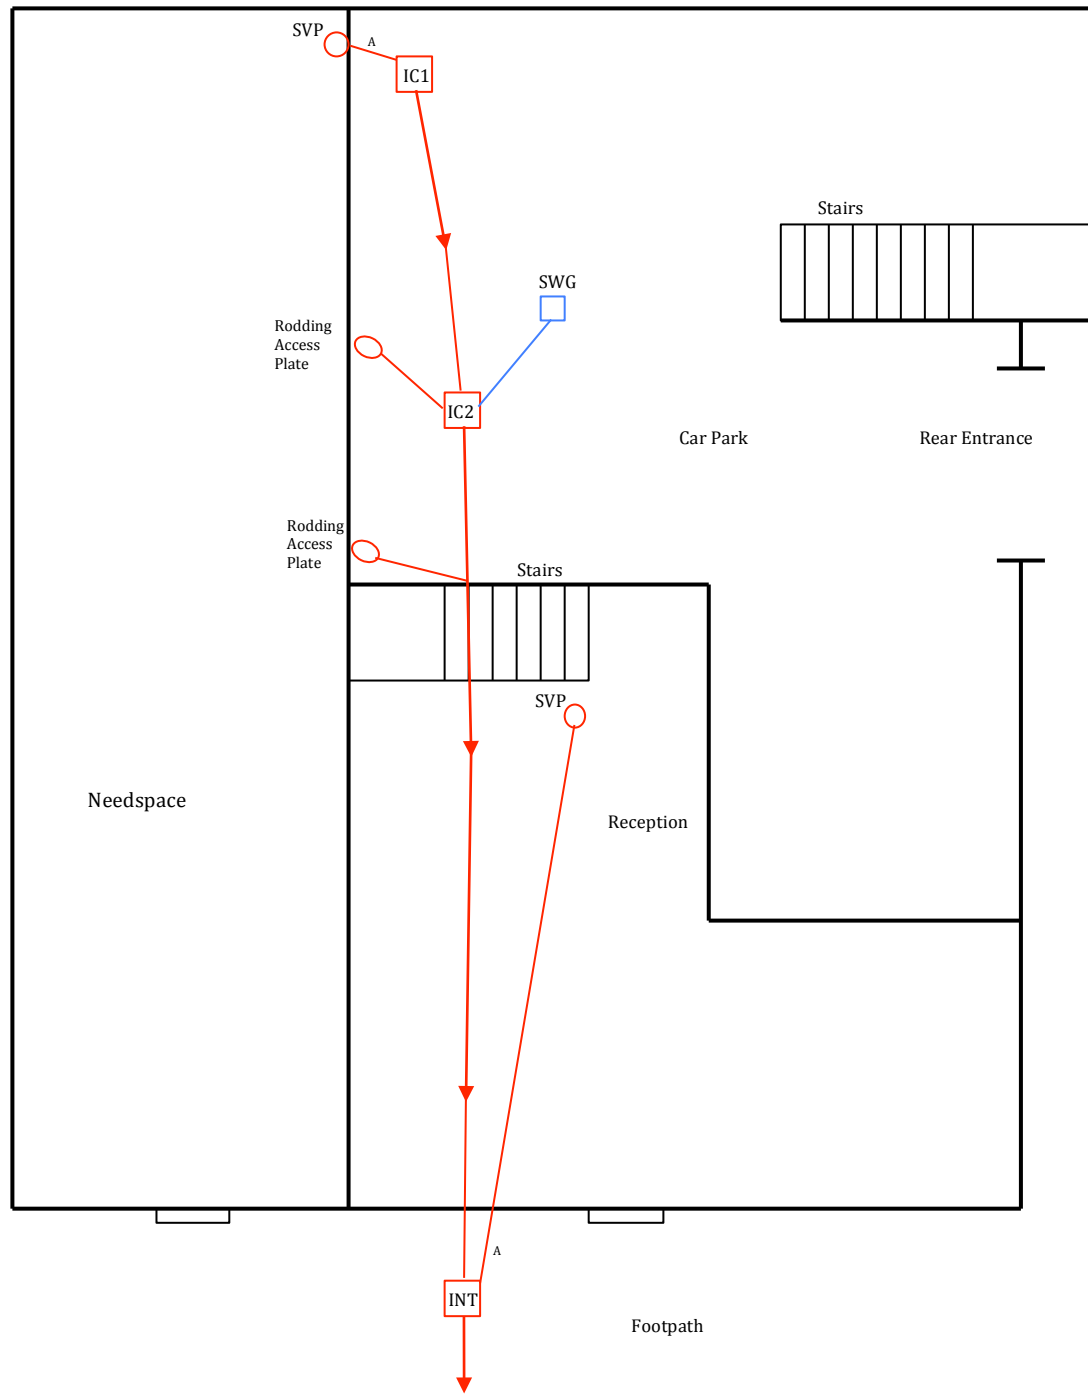
NOT TO SCALE diagram is only a **guide**.

The main drains surveyed were the foul/storm drains that flow from the rear and front of the property highlighted on the diagram.

IC2 is serving a service water gully highlighted on the diagram, on the recording you can see other slippers flowing into this chamber.

INT Line-A flows to a soil stack located where the reception area is highlighted on the diagram.
